Environment Information Session

Lac Bernard

Context for water sampling results

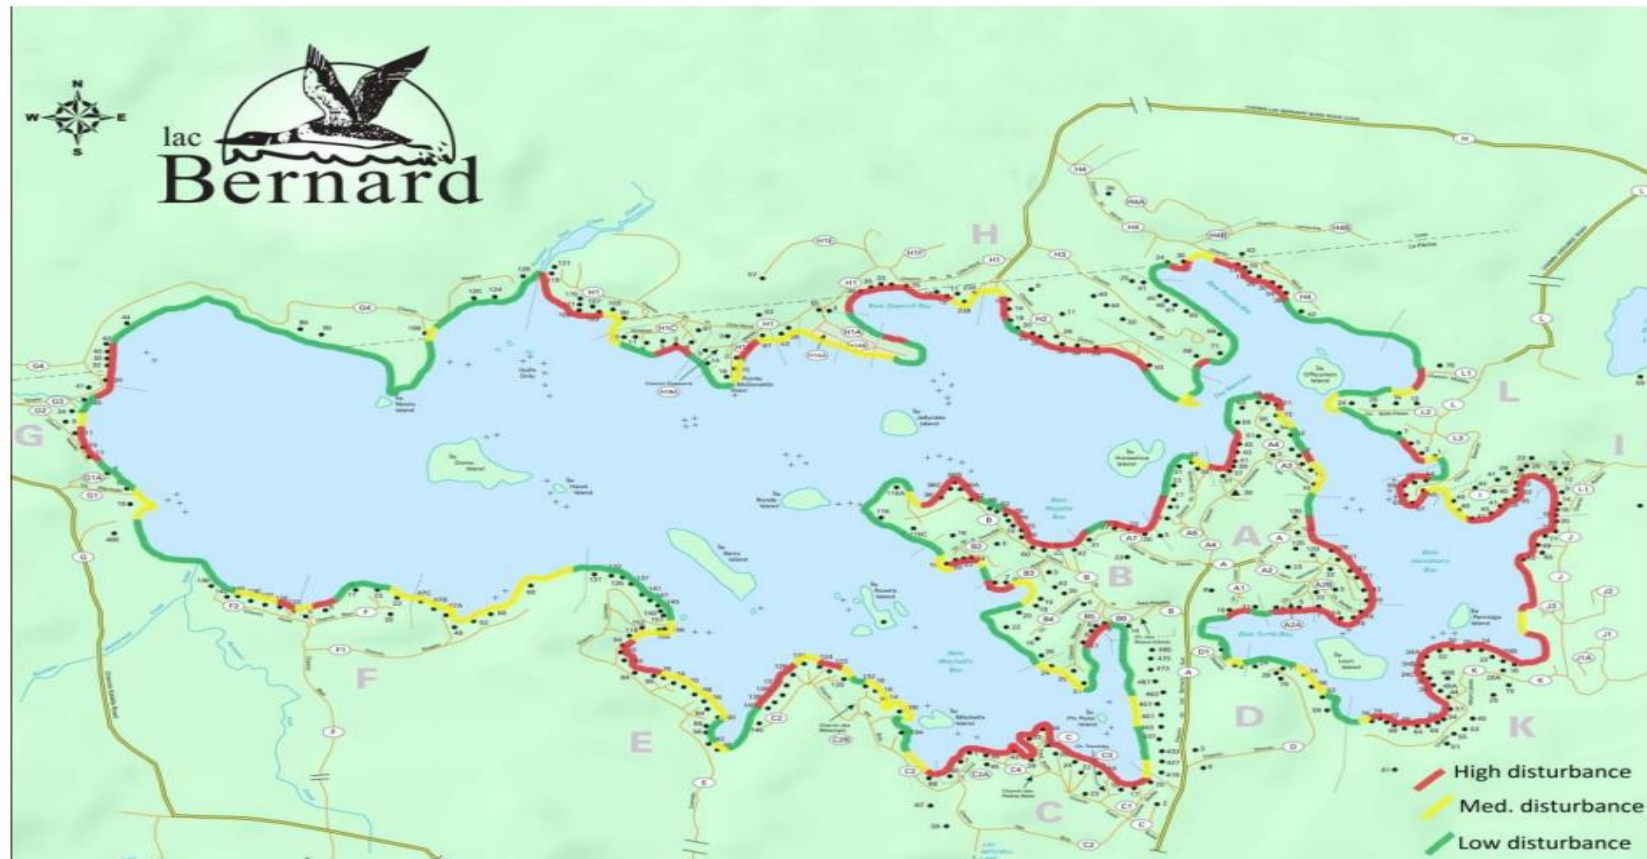
Figure 4. Approximation of shoreline status for Lac Bernard.

SNAPSHOT OF THE SHORELINE FOR WATER QUALITY 2012

Category	Description	Total %

Full 15 m undisturbed	48.3

First 5 m undisturbed then varying disturbance	11.5

First 5m of shoreline disturbed	40.2

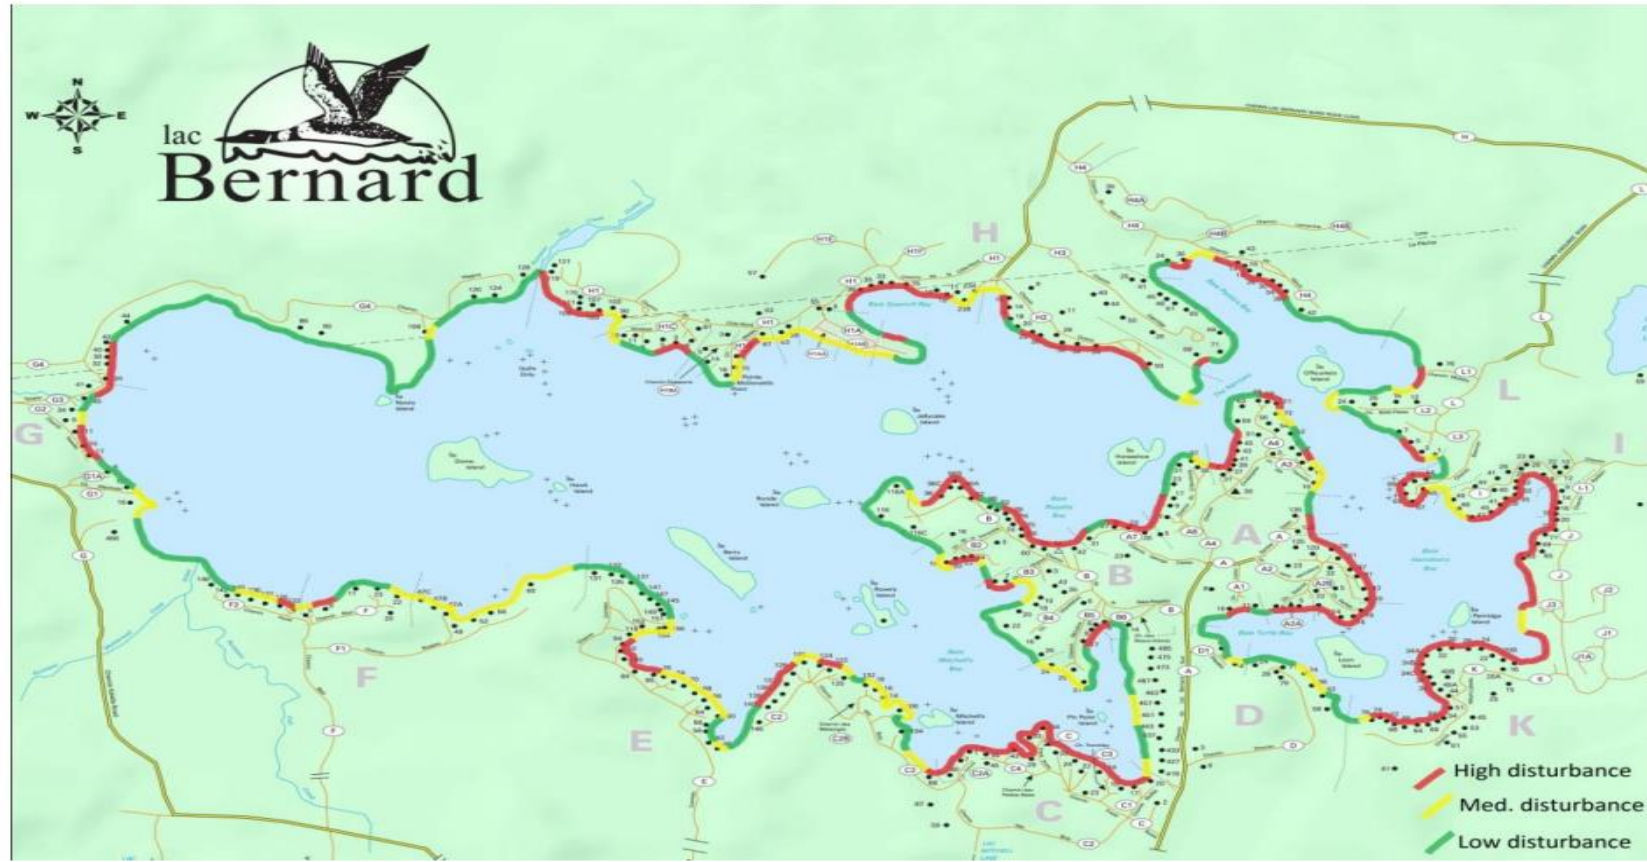
Figure 4. Approximation of shoreline status for Lac Bernard.

Category	Description	Total %

Full 15 m undisturbed	48.3

First 5 m undisturbed then varying disturbance	11.5

First 5m of shoreline disturbed	40.2

- ▶ As context for the water sampling report, the next two slides are important.
- ▶ The 1998 shoreline classification was done by the Quebec government – take note of the amount of green you see around the lake. The green reflects either natural or regenerating shoreline.
- ▶ The 2012 snapshot report was completed through contract to the Association and is on the association website. Just 15 years after the Quebec government's report, less than 50% of the shoreline is characterized as undisturbed within the first 15 metres of the water.
- ▶ Since 2012, there has been further development around the lake and we now have over 400 cottages around the lake.

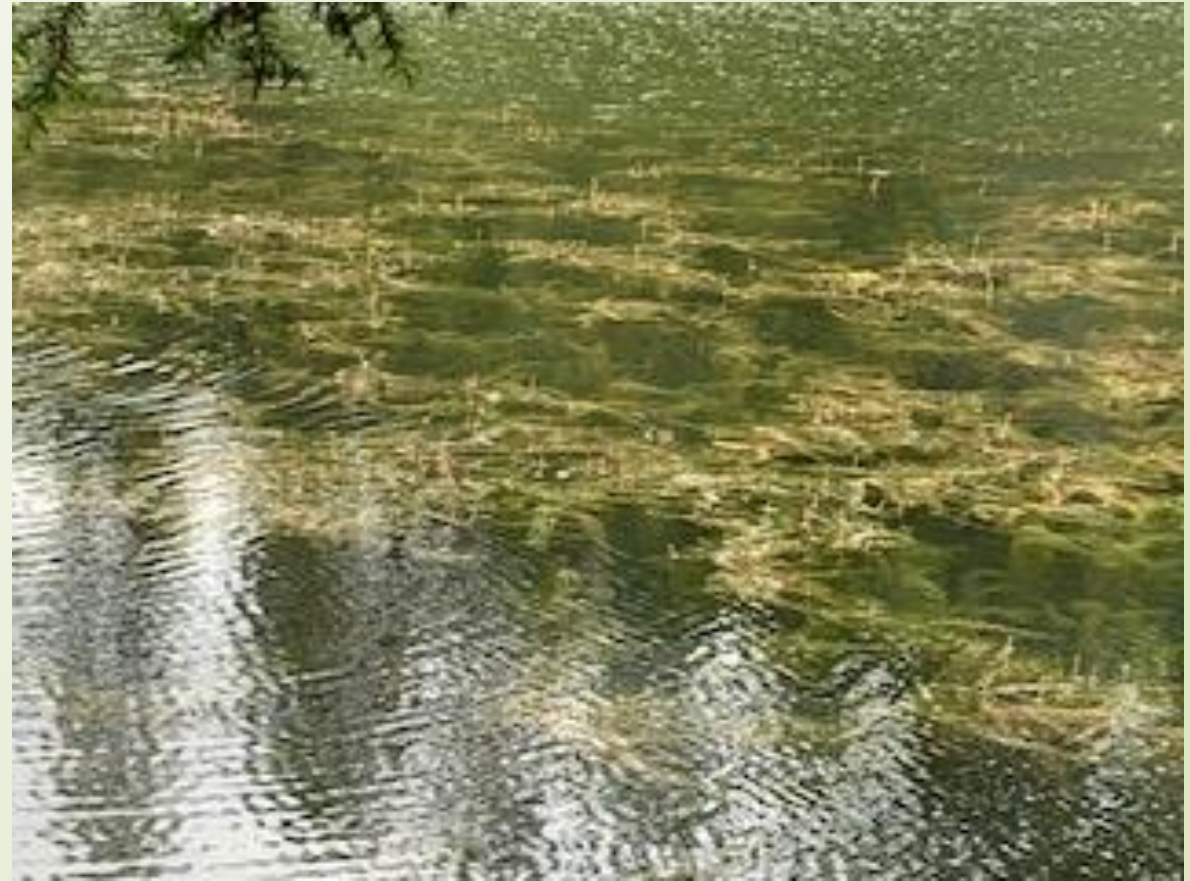
The Outlet is located at the north end of the lake and is on private property.

The outlet is heavily contaminated with milfoil. The shallow water and low levels this summer have caused the milfoil to amass on the surface. Milfoil cuttings that make their way to the Outlet from our lake are settling in this pond.

Typically, during the ice breakup and Springtime snow melt...the Outlet becomes entangled with debris that slows the flow of water from our lake.

This year, we noticed that all the debris is being removed ensuring a steady 'outflow' from our lake

It is consistently being 'cleared' despite the low water levels.

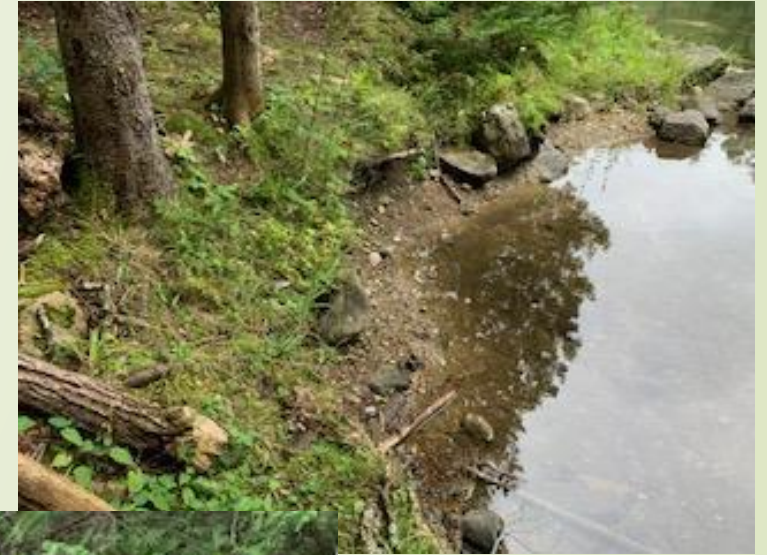
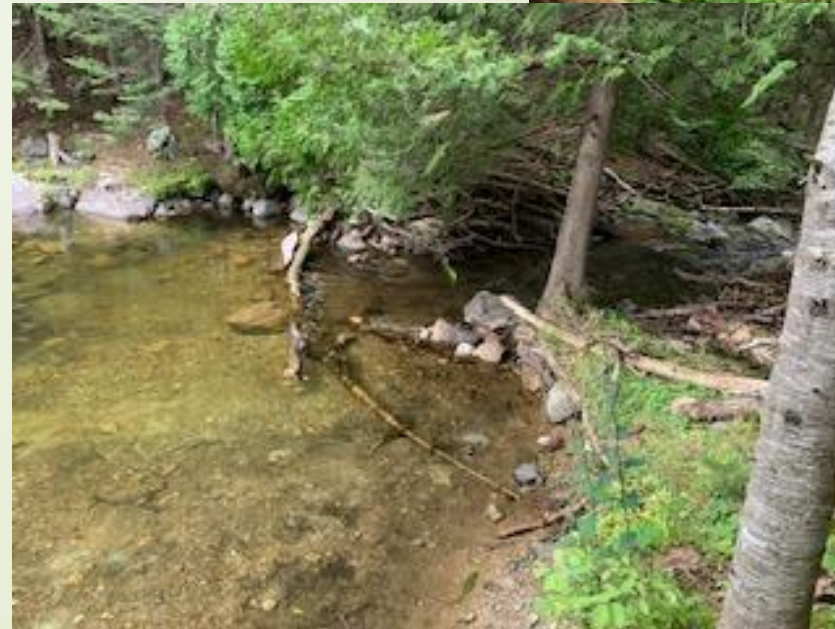
These pictures illustrate the bank along the 'Outlet' just before the 'falls' where water escapes Lac Bernard and moves downstream.

You can clearly see the bank and if you look closely at the rocks, the high- water mark is about 2 feet above the water levels.

The lower picture shows the Outlet itself, where water departs our lake and heads downstream. You can see it is quite narrow, maybe 10-12 feet across, and is easily blocked with debris.

These pictures were taken in August. The water level is much lower now and dropping.

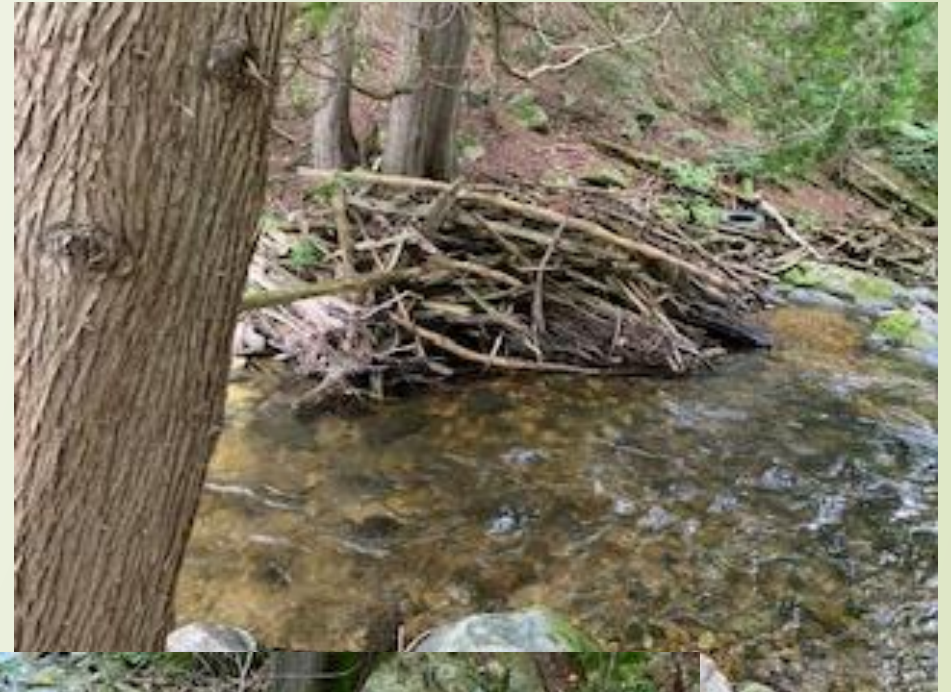
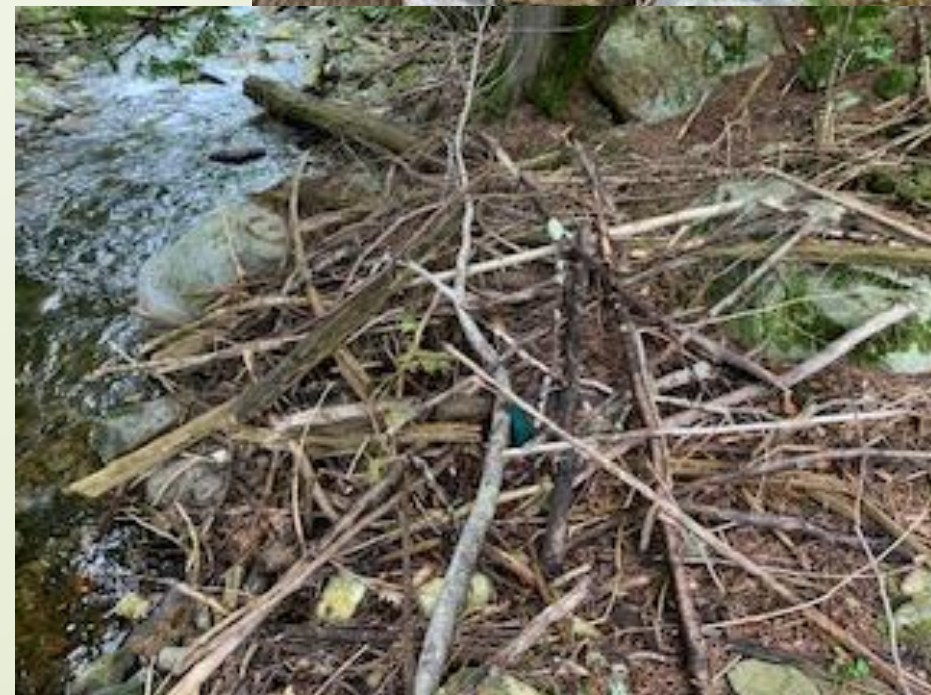
This picture shows the debris that has been removed on the north side and south side of the Outlet 'exit' to where the water literally is free flowing from Lac Bernard.

These pictures were taken in August and you can see the water is flowing quickly, despite the low water levels on the lake proper. The water level continues to free flow from our lake, and will only stop or slow when the water level drops about another 12 inches.

Some debris had accumulated and was slowing the flow, yet again the debris was removed. This was verified in September.

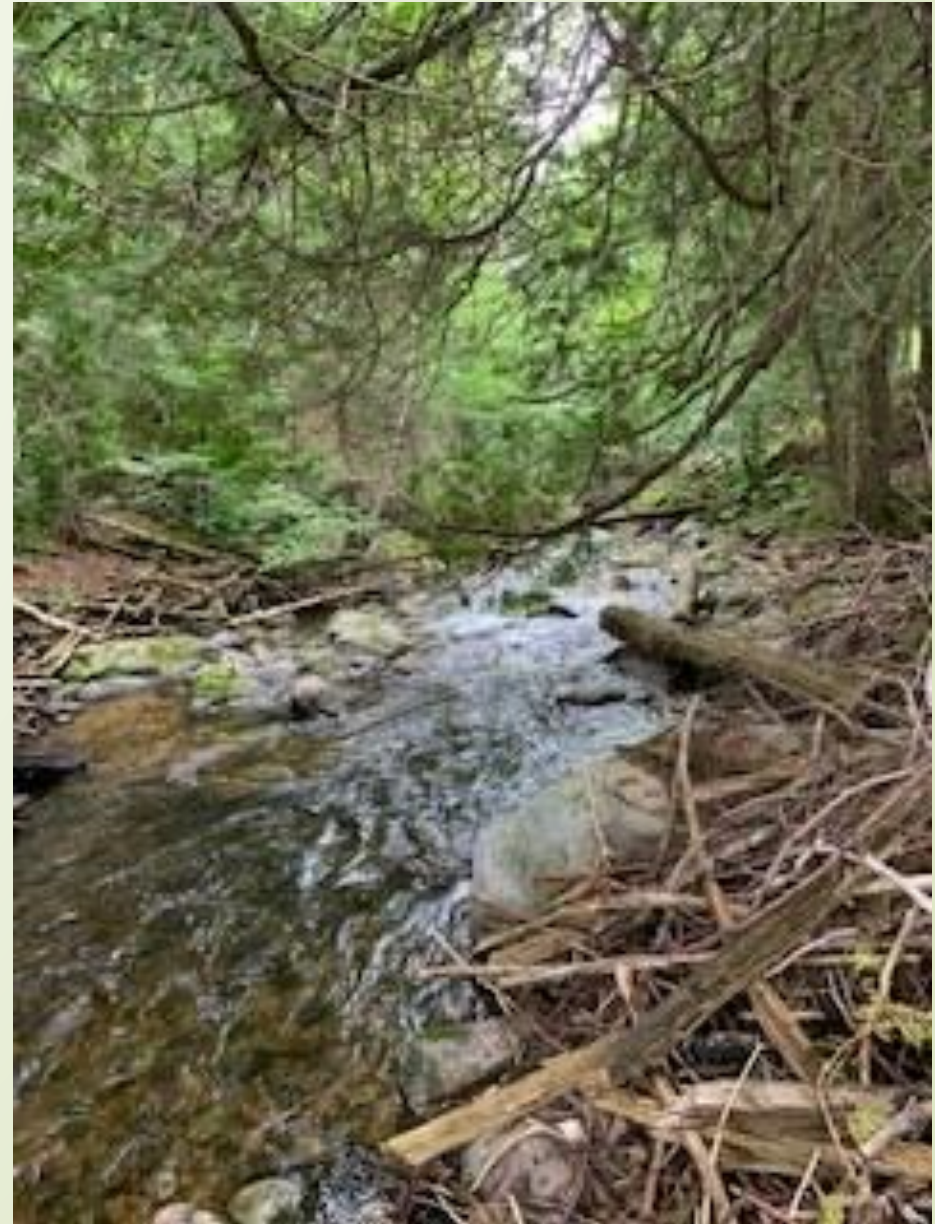
This picture shows the debris that has been removed all the way down the outlet elevation drop – and clearly shows the debris on both sides of the 'river' that has been removed.

This picture was taken in September.

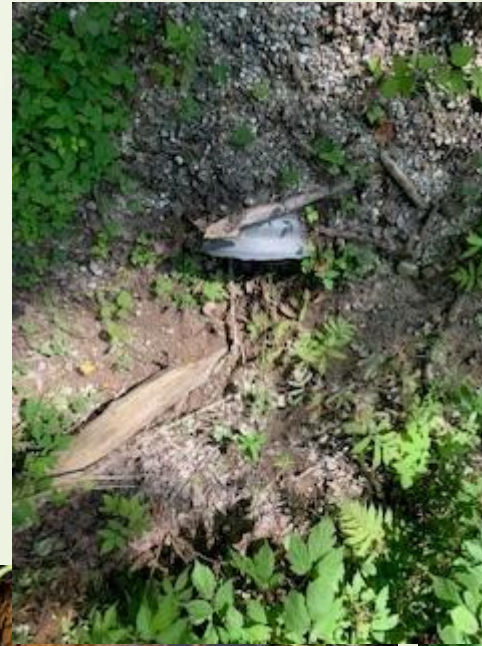
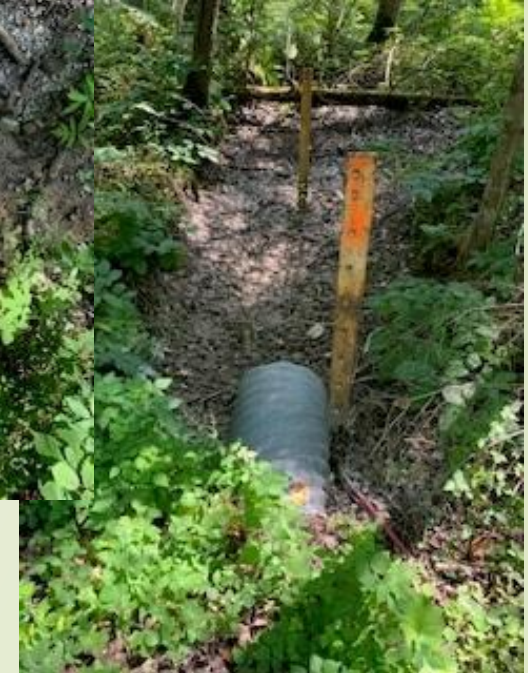
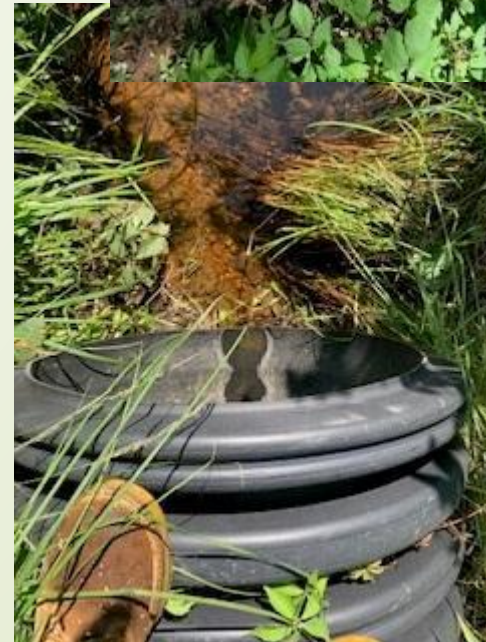
Our lake is fed from Lac Notre Dame, which is a considerable distance from our lake. The Inlet is challenging to traverse on foot or in a vehicle. The Inlet is comprised of mainly two creek systems.

It is not uncommon for obstructions, typically from beavers, to restrict the inflow of new water to our lake.

Despite heavy rains, even deluges, in July...our lake is at the lowest level in recent memory and, until very recently, the inlet was completely blocked.

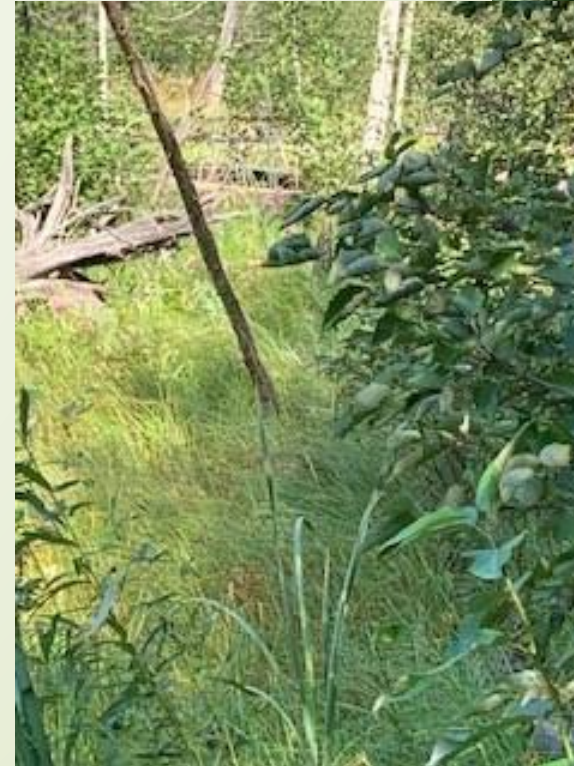
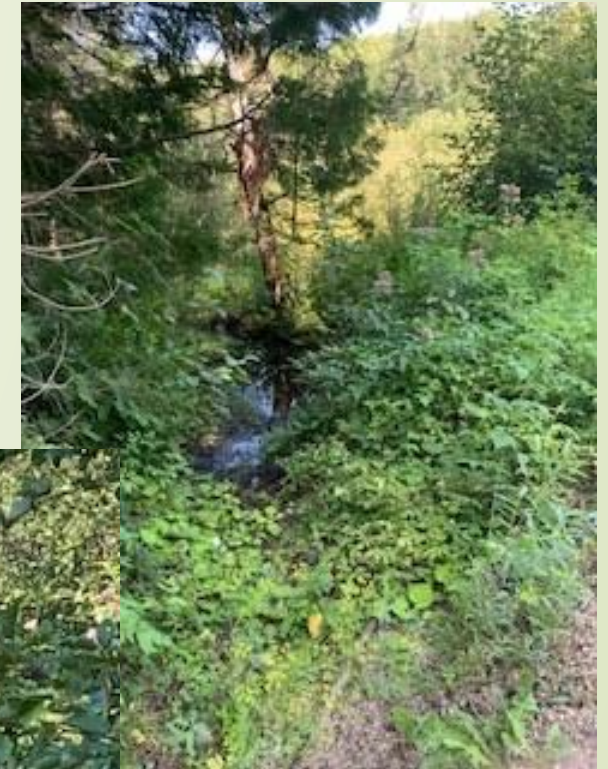
These pictures illustrate some of the challenges to enter and traverse the Inlet system.

Hip-waders are a must,

While volunteers and owners of the properties along the Inlet have helped remove obstructions, perhaps there are ways to help 'nature' allow the free-flow of water into our lake.

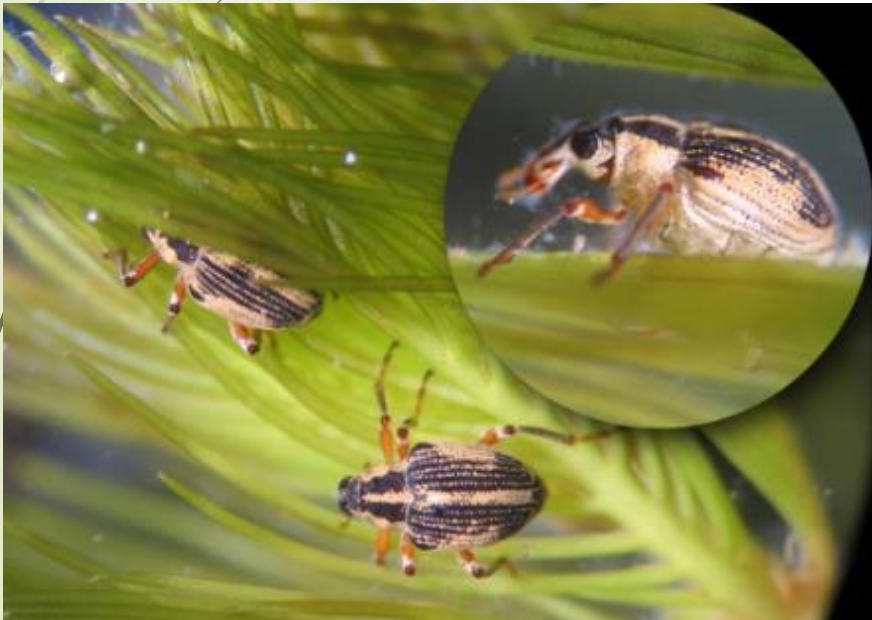
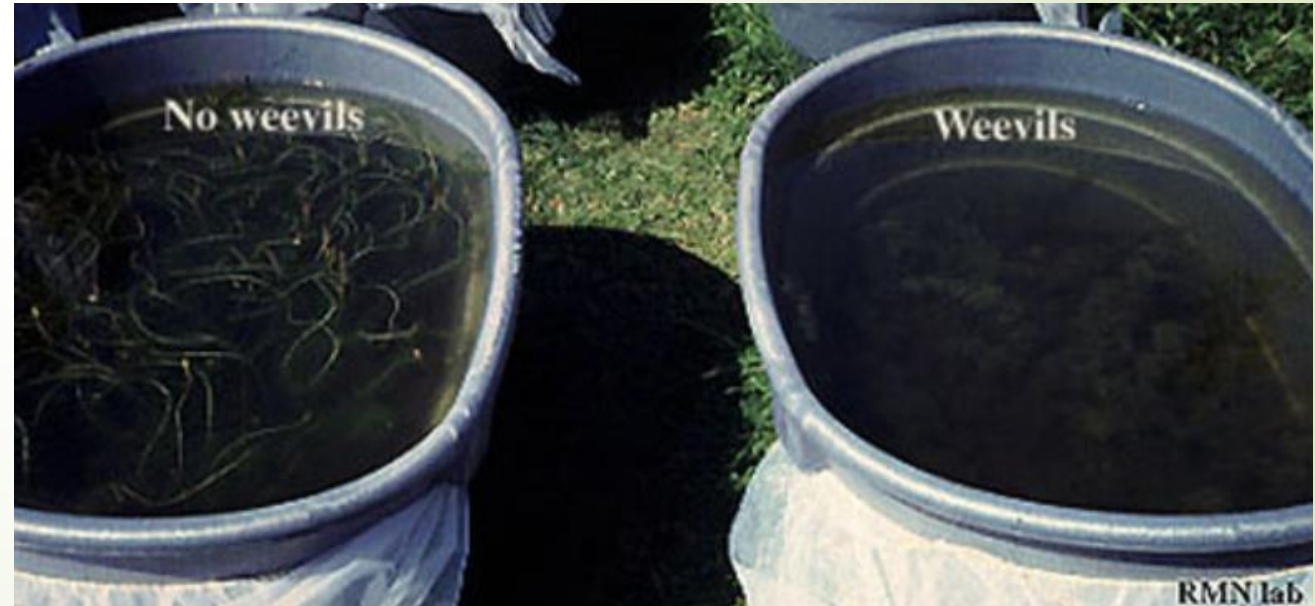
- ▶ Weevils are small beetles (less than 6mm in length)
- ▶ They are indigenous to Lac Bernard as well as most lakes in Ontario and Quebec

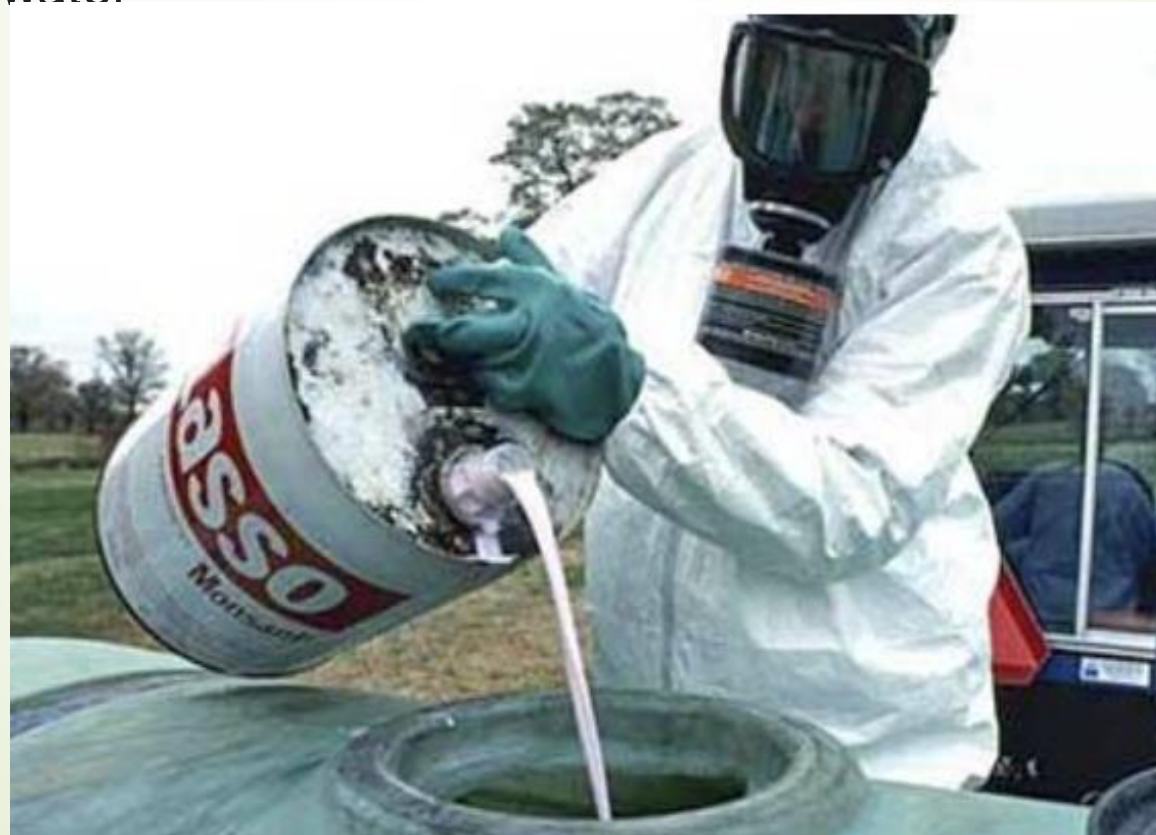
Herbicides

- ▶ 2-4-D, Furoxone (Sonar), Procella (Sepro) or triclopyr will all kill milfoil in the water

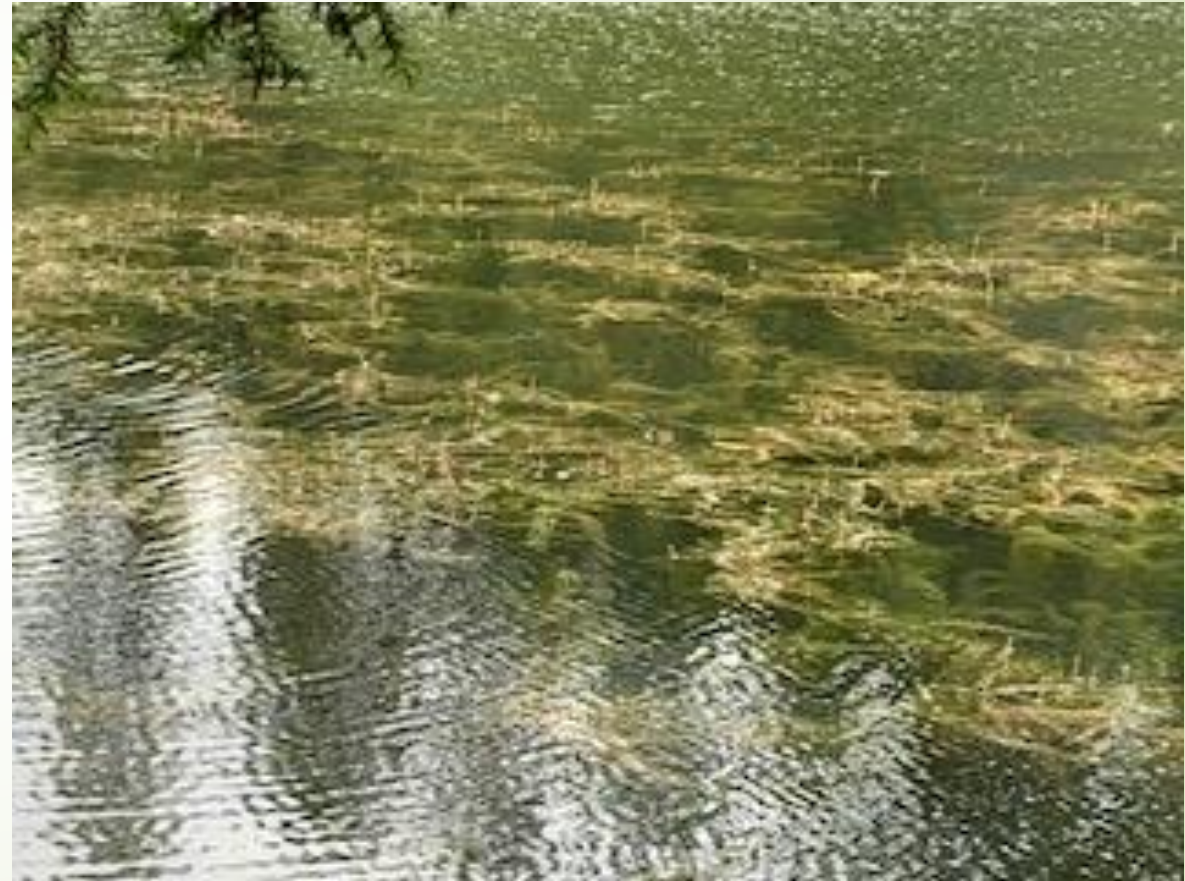
Content: our work to date (3 studies, signs
(education), buoys (avoidance), 75m² burlap
program)...and despite efforts, challenging to
control spread.

580% increase in spread/space where milfoil
has heavy concentration from 2010 initial
study.
